1. Pipeline Rupture – Bellingham Washington, USA

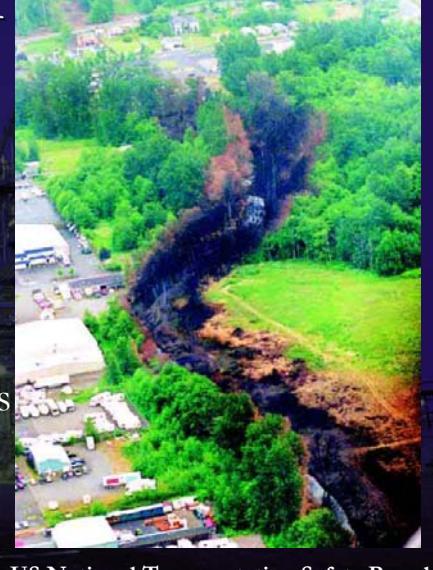
- June 10, 1999
- 16-inch-diameter steel pipeline ruptured
- Released about 237,000 gal (900,000 l) of gasoline
- Ignited and burned approximately 1 1/2 miles (2 km) along the creek.
- Three people died as a result of the accident.

- Damage done to the pipe during the 1994 construction at a water treatment plant
- The pipeline company's inadequate inspection the construction work during the project
- The pipeline company's inaccurate evaluation of inline pipeline inspection results
- The pipeline company's failure to test under approximate operating conditions, all safety devices

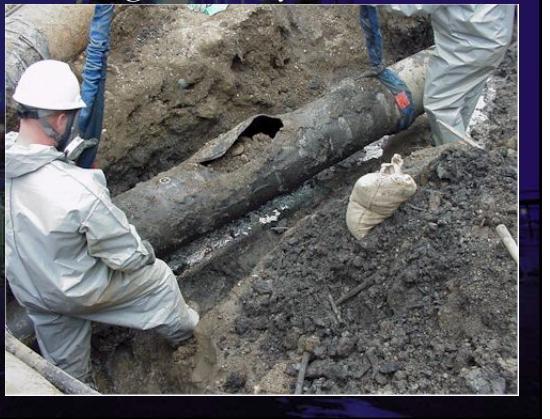
- Fracture originated at an external gouge mark in the pipe that was approximately 8 1/2 in. (220 mm) long and oriented longitudinally.
- Gouge reduced the wall thickness of the pipeline by approximately 20 percent.

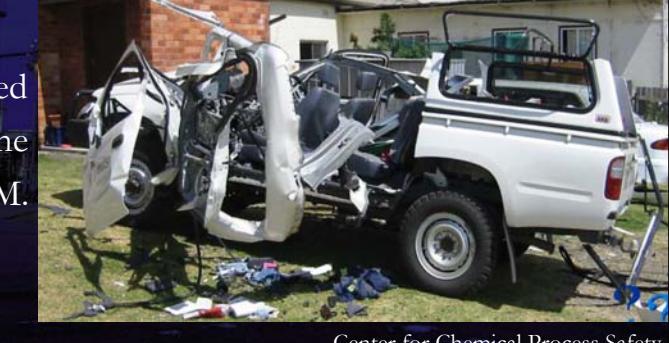
- A pickup truck with a small cylinder of acetylene stored in the cab was parked for the weekend.
- The cylinder had a small leak.
- A flammable atmosphere developed inside the truck's cab.
- When the
 - owner returned and opened the door---BOOM.

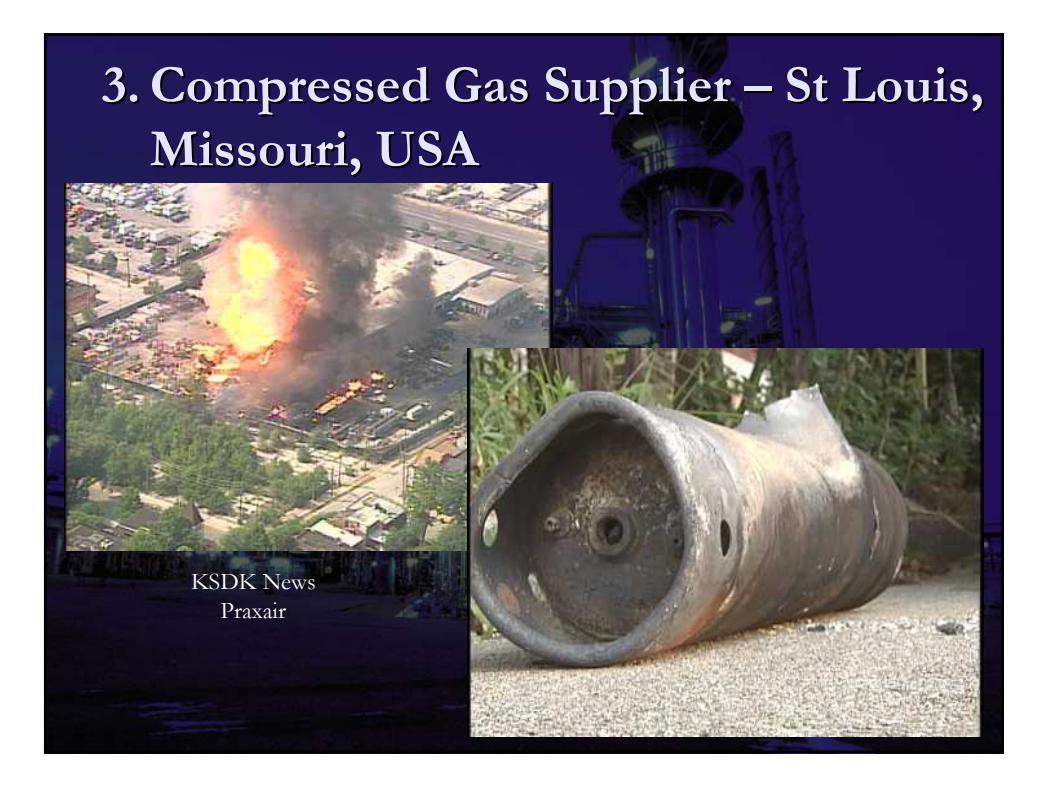
- June, 2005 spectacular fire and series of explosions
- Projectiles flew from the plant as far as 900 feet (275 meters)
- A safety relief device on a cylinder located in an area where empty propane or propylene cylinders were stored at the site vented with high energy.
- The escaping gas ignited, the flame impacted other cylinders and heated them to the point that they too vented.

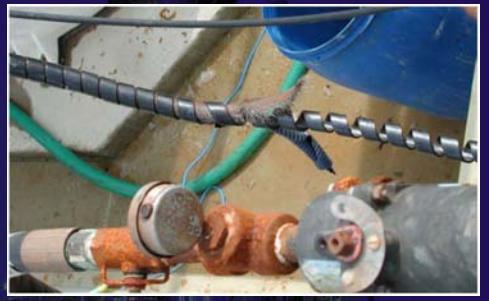
August, 2002 - Chlorine was being transferred from a railroad tank car when the transfer hose burst.

- Both automatic and manual emergency shutdown systems failed
- The release was unabated for about three hours before emergency responders were able to stop the release.
- They entered the chlorine cloud wearing "Class A" safety gear and climbed on top of the car to close the manual shut off valves.
- Three people were hospitalized.

- The ruptured hose should have had an inner Teflon liner reinforced with a C-276 exterior metal braid.
 - with a C-270 extend metal blatt.
 - Instead the braid was stainless steel.
 - The hose failed after less than 2 months of service.
 - Both the purchase and shipping papers indicated that the hose was constructed of the proper materials.
- An emergency shut down system failed to work because of severe build up on the valve ball.

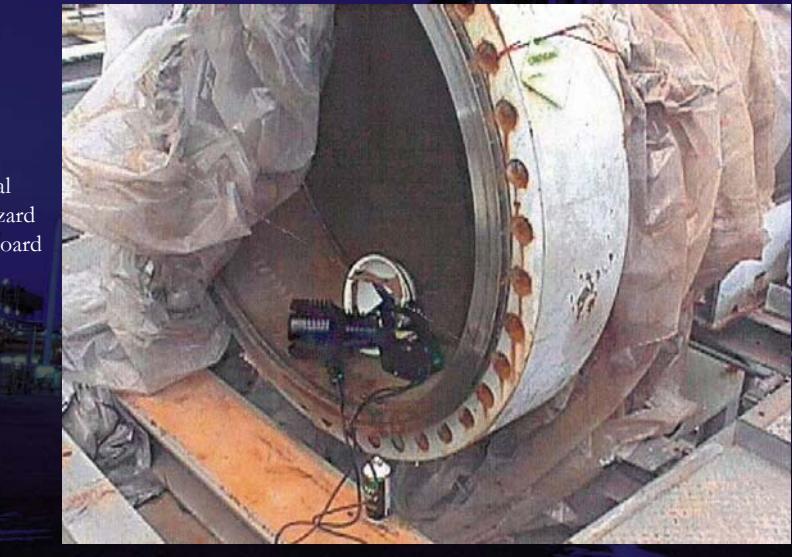
- March, 1998
- One dead, one injured
- Two workers were overcome by nitrogen gas while performing a black light inspection1 at an open end of a NPS 48 horizontal pipe.
- Nitrogen was being injected into connected process equipment to protect catalyst
- The nitrogen was venting from one side of the open pipe where it had formerly been connected to a mixer.

- Procedures to control potential hazards created by erecting temporary enclosures around nitrogen-containing equipment were inadequate.
- Nitrogen and confined space hazard warnings were inadequate.

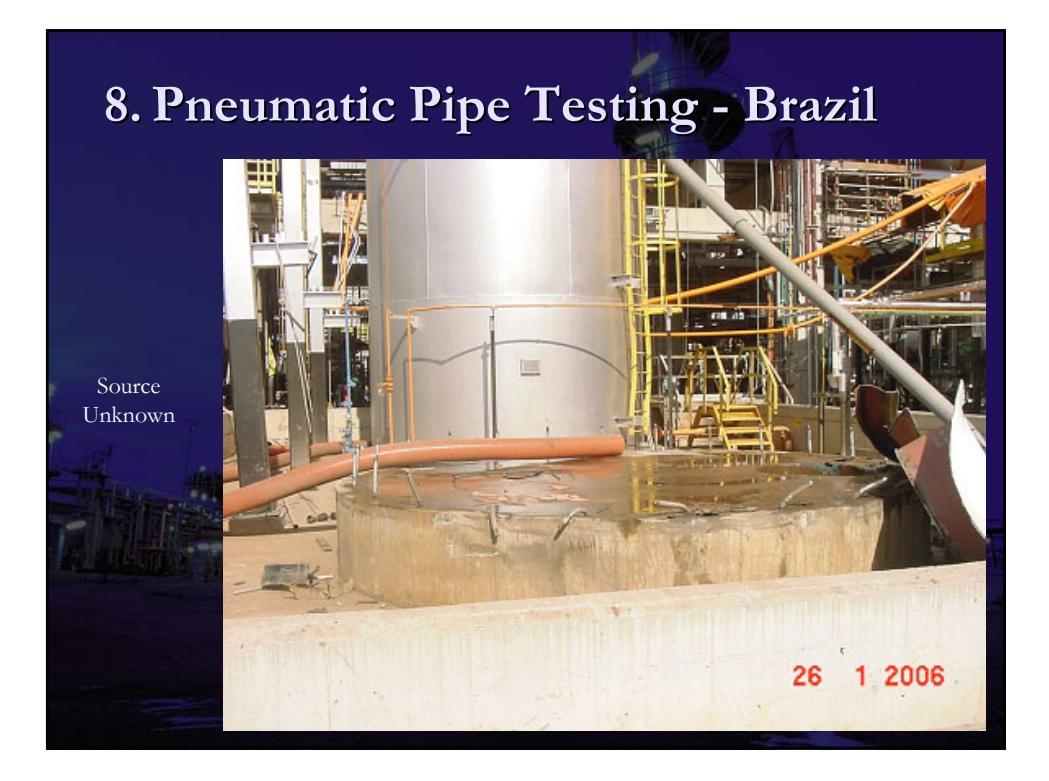
- Incident happened during a pneumatic test of the tank associated piping.
- Block valves were closed to isolate the piping.
- Block valve(s) leaked through and over pressured the tank.
- Primary cause: failure to install blanks or blinds to isolate the test segment.
